INDIANA DEPARTMENT OF ENVIRONMENTAL MANAGEMENT SITE INSPECTION REPORT

WEBB WELL FIELD

FRANKLIN, INDIANA

JANUARY 24, 2011

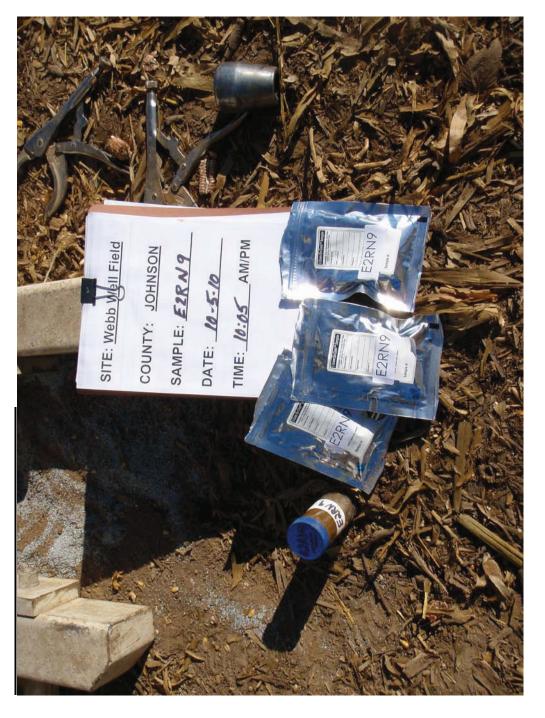
WEATHER: Sunny Mild **SAMPLE TYPE:** Subsurface Soil **TIME**: 10:05 AM DATE: October 5, 2010
SAMPLE ID # E2RN9 **DESCRIPTION:** Close up of sample E2RN9 collected 14' deep from boring 1, in com field west of Webb municipal wells near Hurricane Creek.

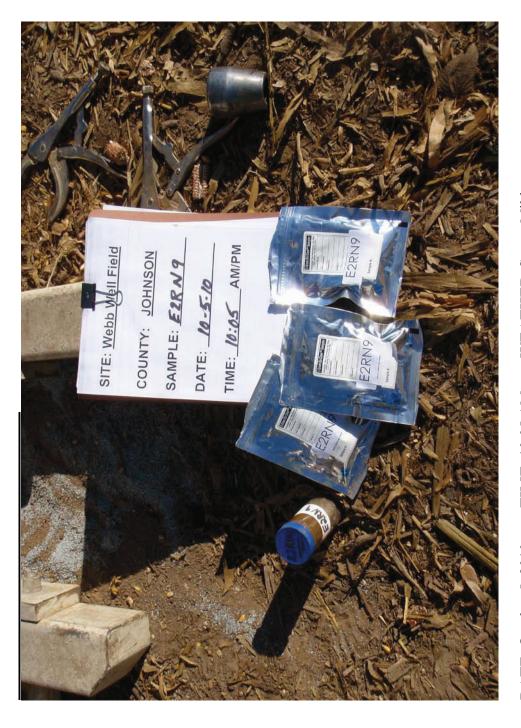
DATE: October 5, 2010TIME: 10:05 AMWEATHER: Sunny MildSAMPLE ID # E2RN9SAMPLE TYPE: Subsurface Soil

DESCRIPTION: Picture with background of sample E2RN9 collected 14' deep from boring 1, in corn field west of Webb municipal wells near Hurricane Creek.

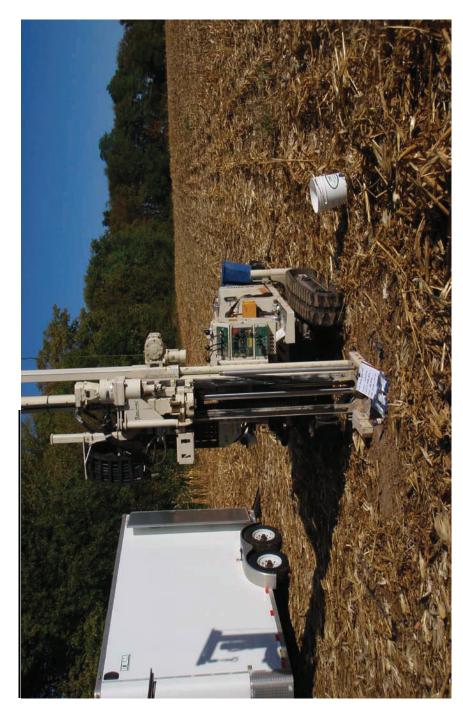
DESCRIPTION: Close up of sample E2RN9 collected 14' deep from boring 1, in corn field west of Webb municipal wells near Hurricane Creek.

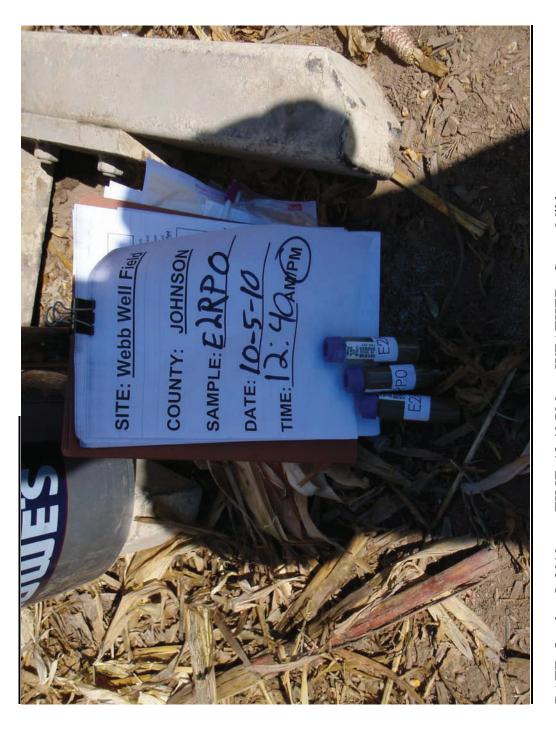
DATE: October 5, 2010TIME: 12:40 PMWEATHER: Sunny MildSAMPLE ID # E2RP0SAMPLE TYPE: Ground Water

DESCRIPTION: Close up of sample E2RP0 collected 46' deep from boring 1, in corn field west of Webb Municipal wells near Hurricane Creek.

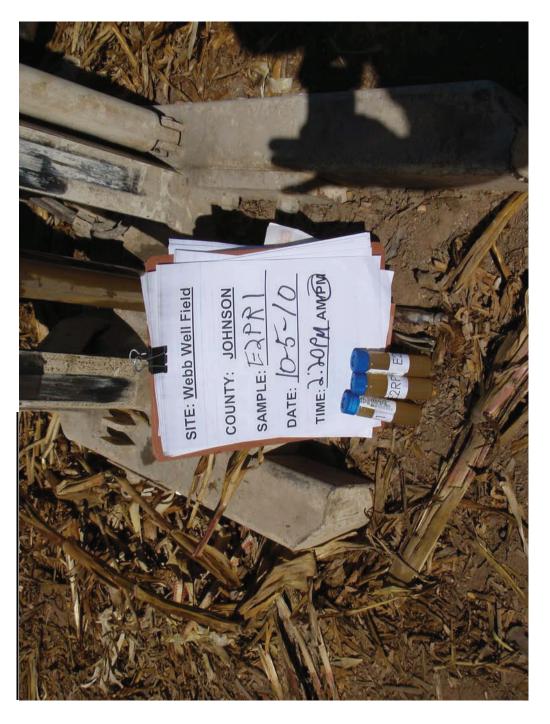
WEATHER: Sunny Mild SAMPLE TYPE: Ground Water **TIME**: 2:40 PM **DATE**: October 5, 2010 SAMPLE ID # E2RP1 **DESCRIPTION:** Close up of sample E2RP1 collected 30' deep from boring 1, in corn field west of Webb municipal wells near Hurricane Creek.

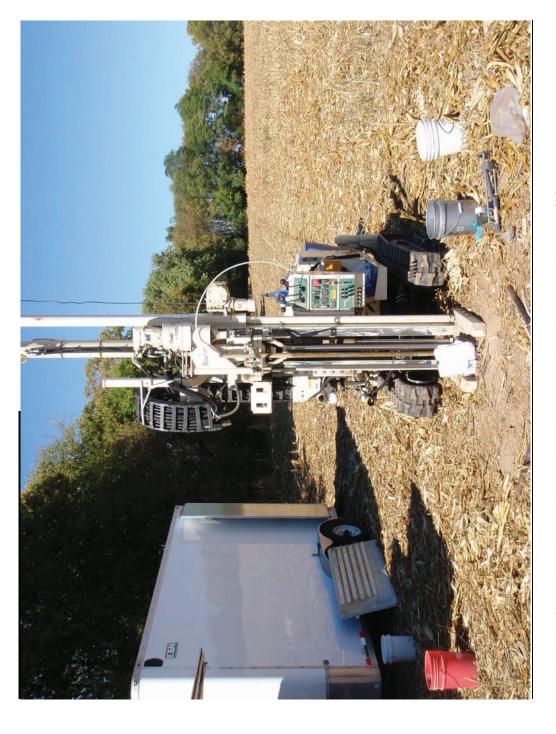
DATE: October 5, 2010TIME: 2:20 PMWEATHER: Sunny MildSAMPLE ID # E2RP1SAMPLE TYPE: Ground Water

DESCRIPTION: Picture with background of sample E2RP1 collected 30' deep from boring 1, in corn field west of Webb municipal wells near Hurricane Creek.

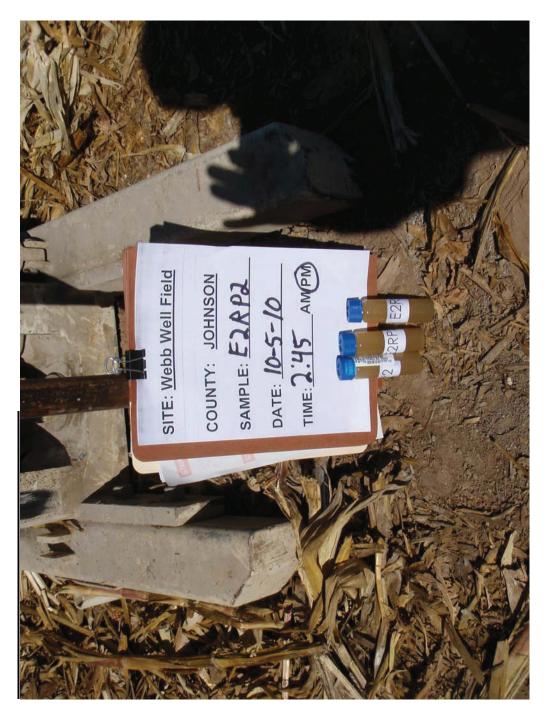
DATE: October 5, 2010TIME: 2:45 PMWEATHER: Sunny MildSAMPLE ID # E2RP2SAMPLE TYPE: Ground Water

DESCRIPTION: Close up of sample E2RP2 collected 15' deep from boring 1, in corn field west of Webb municipal wells near Hurricane Creek.

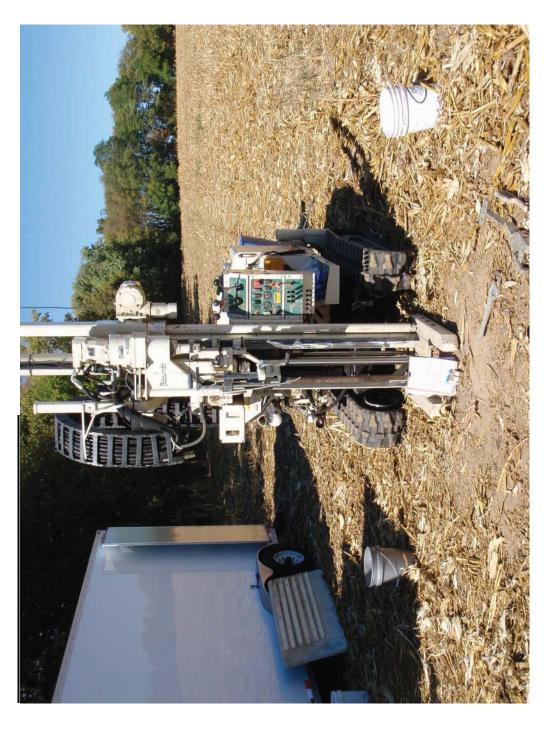
DATE: October 5, 2010TIME: 2:45 PMWEATHER: Sunny MildSAMPLE ID # E2RP2SAMPLE TYPE: Ground Water

DESCRIPTION: Picture with background of sample E2RP2 collected 15' deep from boring 1, in corn field west of Webb municipal wells near Hurricane Creek.

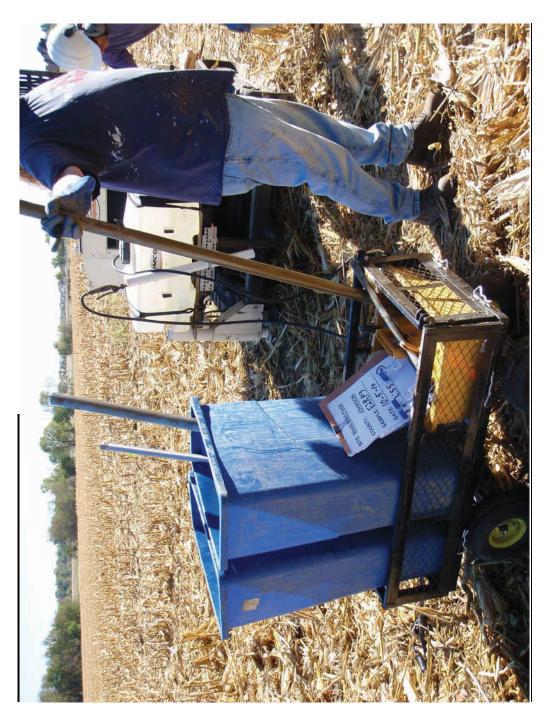
DATE: October 5, 2010TIME: 2:55 PMWEATHER: Sunny MildSAMPLE ID # E2RP3SAMPLE TYPE: Equipment Blank

DESCRIPTION: Close up of sample E2RP3, equipment blank.

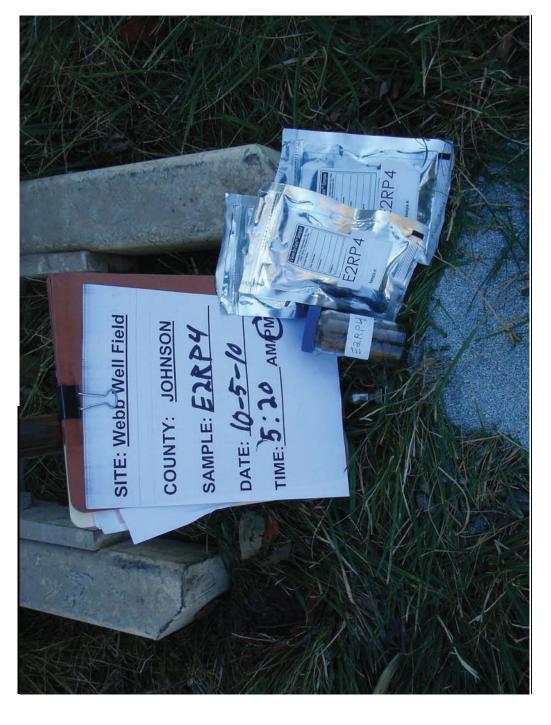
DATE: October 5, 2010TIME: 5:20 PMWEATHER: Sunny MildSAMPLE ID # E2RP4SAMPLE TYPE: Subsurface Soil

DESCRIPTION: Close up of sample E2RP4 collected 6' deep from boring 2, 100' south of upper Shelbyville Road south of the Webb Well Field facility.

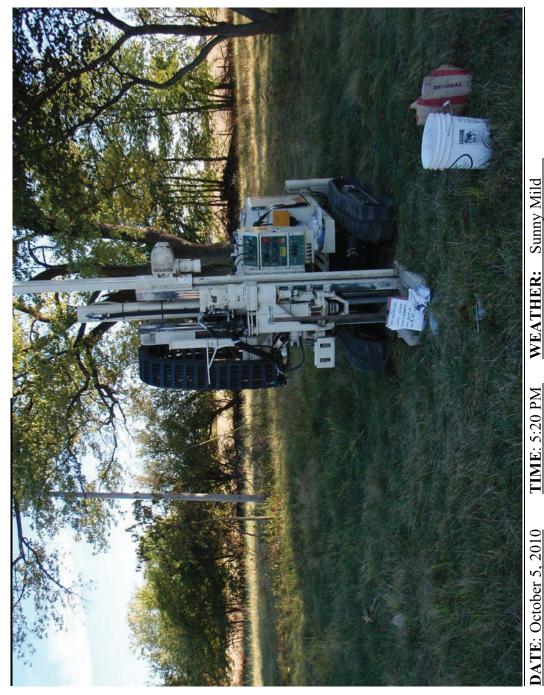
DATE: October 5, 2010TIME: 5:20 PMWEATHER:SAMPLE ID # E2RP4SAMPLE TYPE: Subsurface Soil

DESCRIPTION: Picture with background of sample E2RP4 collected 6' deep at boring 2 100' south of upper Shelbyville Road south of the Webb Well Field facility.

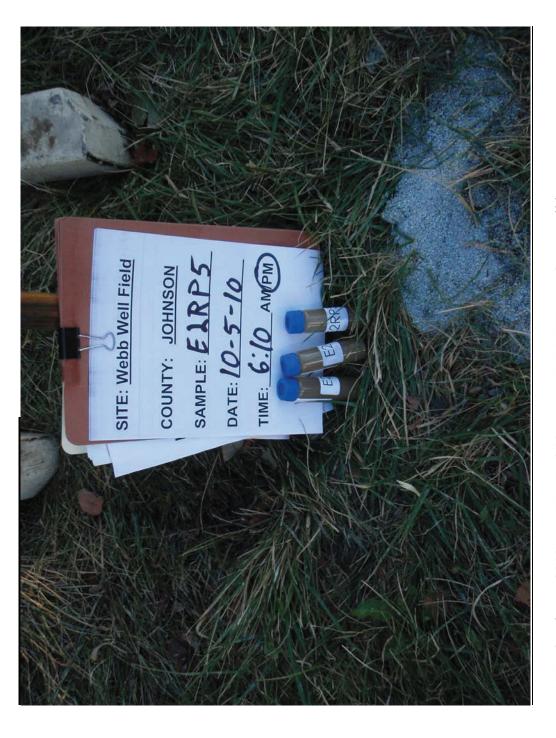
DATE: October 5, 2010TIME: 6:10 PMWEATHER: Sunny MildSAMPLE ID # E2RP5SAMPLE TYPE: Ground Water

DESCRIPTION: Close up of sample E2RP5 collected 22' deep from boring 2, 100' south of upper Shelbyville Road south of the Webb Well Field facility.

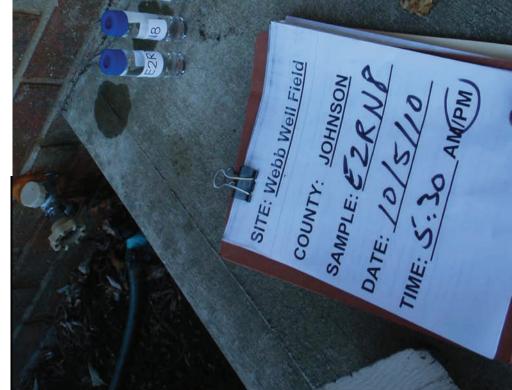
DESCRIPTION: Picture with background of sample E2RP5, collected 22' deep at boring 2, 100' south of upper Shelbyville Road south of the Webb Well Field facility.

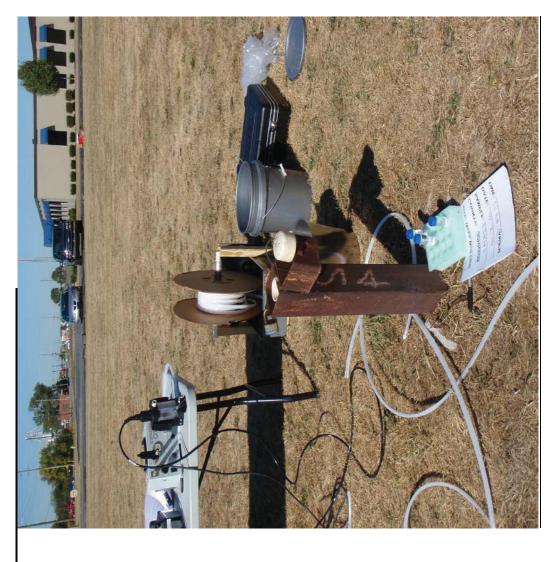
DATE: October 5, 2010TIME: 11:59 AMWEATHER: Sunny MildSAMPLE ID # E2RM2SAMPLE TYPE: Ground water, Monitoring Well

DESCRIPTION: Close up of sample E2RM2 collected at Amphenol facility monitoring well, 1.65' deep.

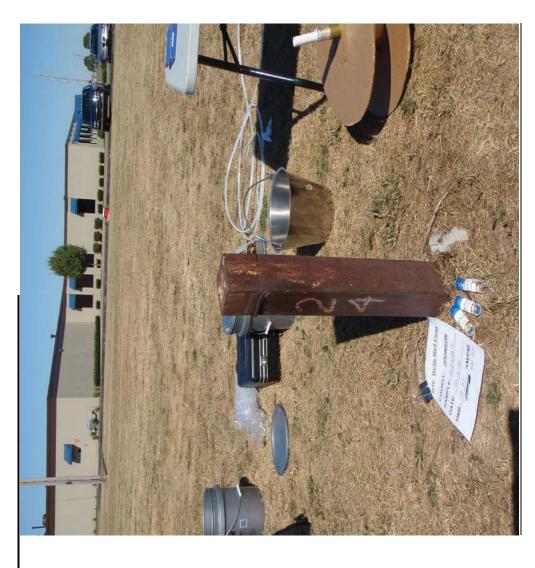
SAMPLE TYPE: Ground water, Monitoring Well, Duplicate WEATHER: Sunny Mild **TIME**: 12:01 PM DATE: October 5, 2010
SAMPLE ID # E2RM3

DESCRIPTION: Close up of sample E2RM3 collected at Amphenol facility monitoring well, 1.65' deep.

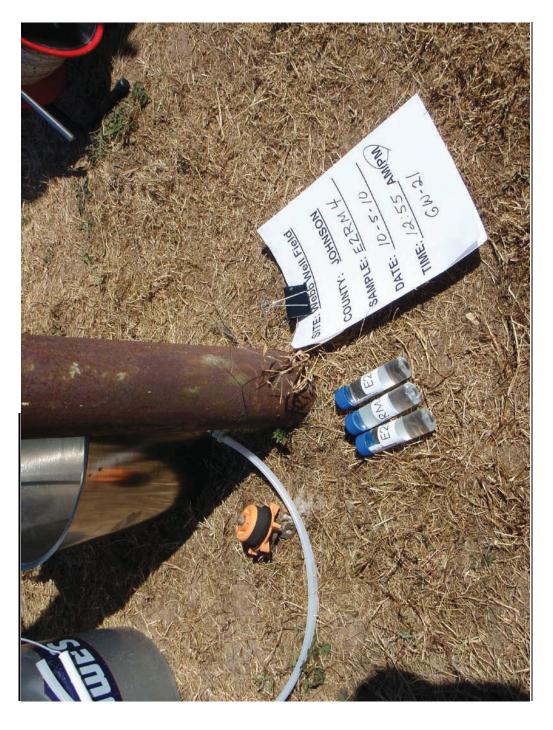
TIME: 12:01 PM WEATHER: Sunny Mild SAMPLE TYPE: Ground Water, Monitoring Well,

DESCRIPTION: Taken with background of sample E2RM3 collected at Amphenol facility monitoring well, 16.5' deep.

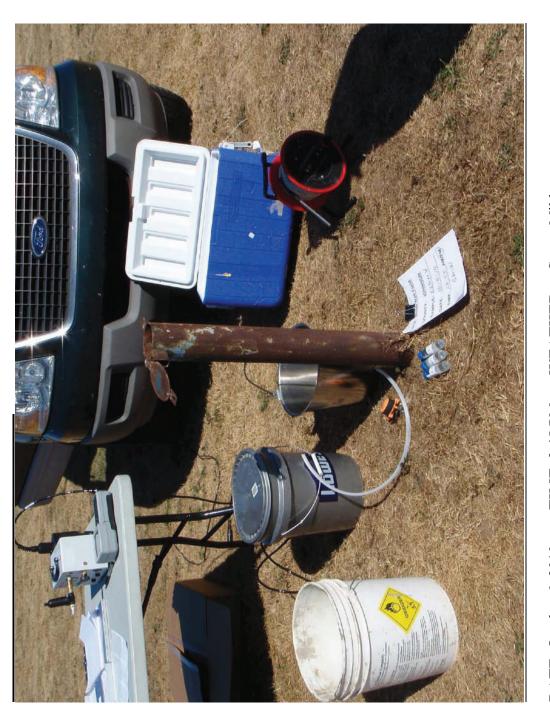
WEATHER: Sunny Mild **TIME**: 12:55 PM SAMPLE ID # E2RM4 DATE: October 5, 2010

SAMPLE TYPE: Ground water, Monitoring Well

DESCRIPTION: Close up of sample E2RM4 collected at Amphenol facility monitoring well, 58' deep.

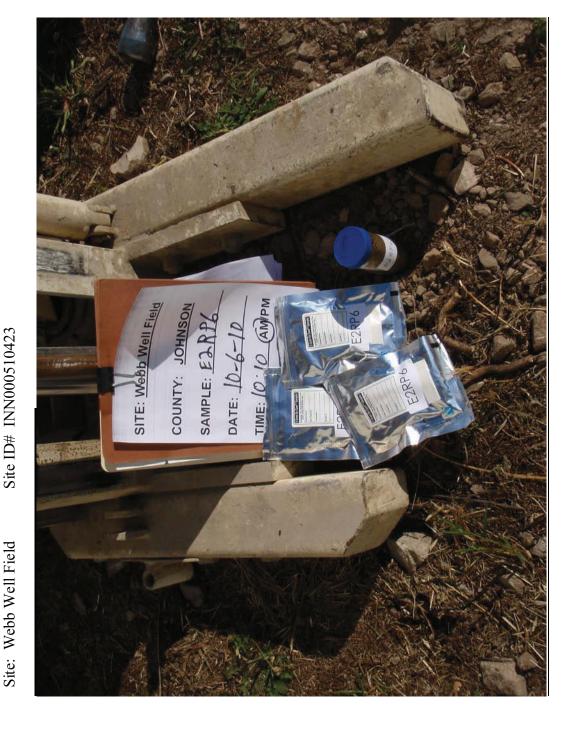
WEATHER: Sunny Mild **SAMPLE TYPE:** Subsurface Soil **TIME**: 10:10 AM DATE: October 6, 2010 SAMPLE ID # E2RP6

DESCRIPTION: Close up of sample E2RP6 collected at Atlas Copco facility, Boring 3, 12.5' deep.

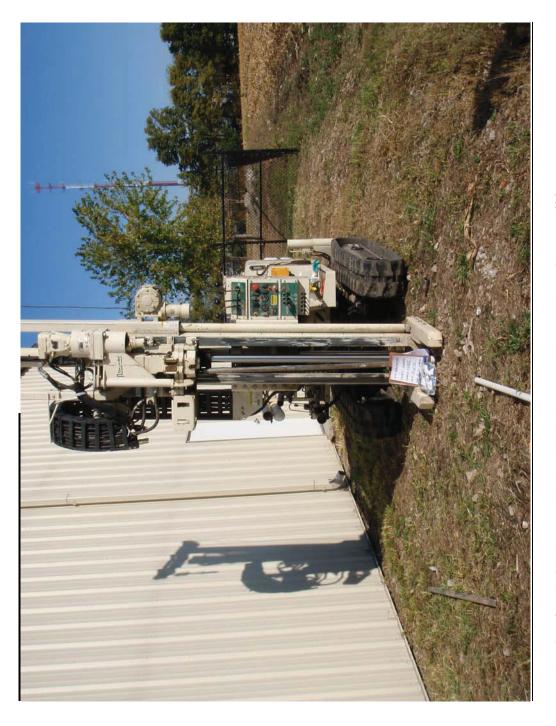
DATE: October 6, 2010TIME: 10:10 AMWEATHER: Sunny MildSAMPLE ID # E2RP6SAMPLE TYPE: Subsurface Soil

DESCRIPTION: Taken with background of sample E2RP6 collected at Atlas Copco facility Boring 3, 12.5' deep.

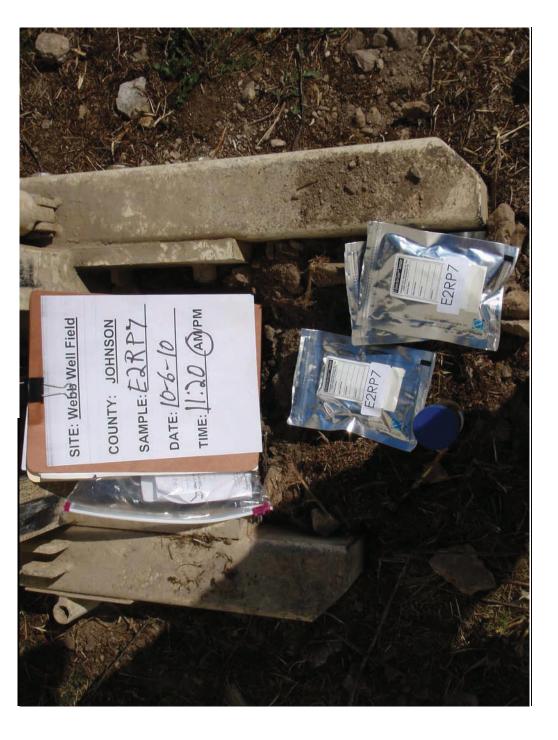
DATE: October 6, 2010 SAMPLE ID # E2RP7

WEATHER: Sunny Mild TIME: 11:20 AM WEATHER: Sunny Mi SAMPLE TYPE: Subsurface Soil, Duplicate **DESCRIPTION:** Close up of sample E2RP7 collected at Atlas Copco facility, Boring 3, 12.5' deep.

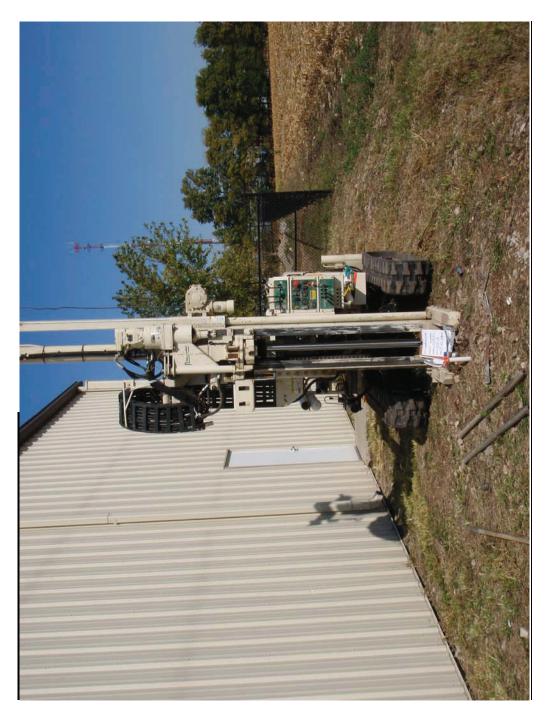
DATE: October 6, 2010TIME: 11:20 AMWEATHER: Sunny MildSAMPLE ID # E2RP7SAMPLE TYPE: Subsurface Soil, Duplicate

DESCRIPTION: Taken with background of sample E2RP7 collected at Atlas Copco facility Boring 3, 12.5' deep.

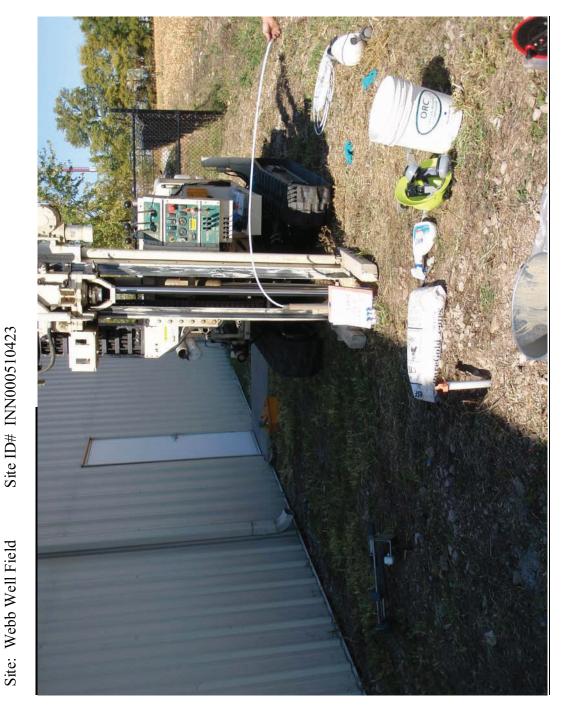
WEATHER: Sunny Mild Ground Water SAMPLE TYPE: **TIME**: 2:30 PM DATE: October 6, 2010 SAMPLE ID # E2RP8 **DESCRIPTION:** Taken with background of sample E2RP8 collected at Atlas Copco facility Boring 3, 41' deep.

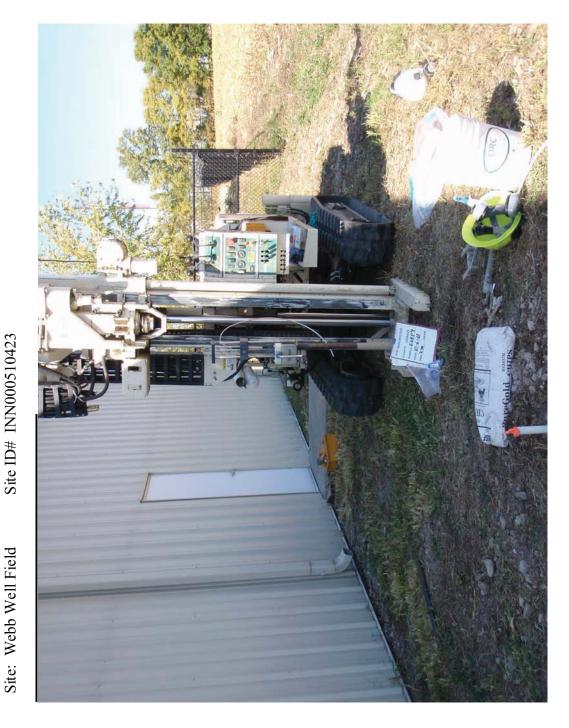
DESCRIPTION: Close up of sample E2RP9 collected at Atlas Copco facility, Boring 3, 30' deep.

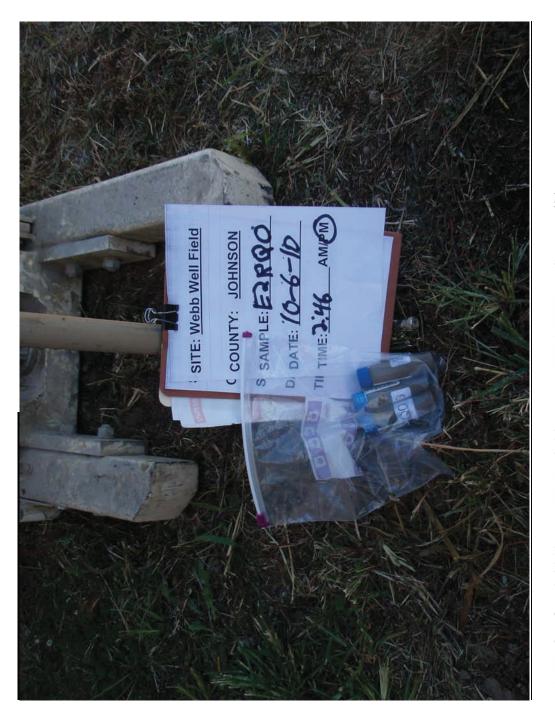
WEATHER: Sunny Mild SAMPLE TYPE: Ground Water, Duplicate **TIME**: 2:46 PM DATE: October 6, 2010 SAMPLE ID # E2RQ0 **DESCRIPTION:** Close up of sample E2RQ0 collected at Atlas Copco facility, Boring 3, 30' deep,

Duplicate of E2RP9.

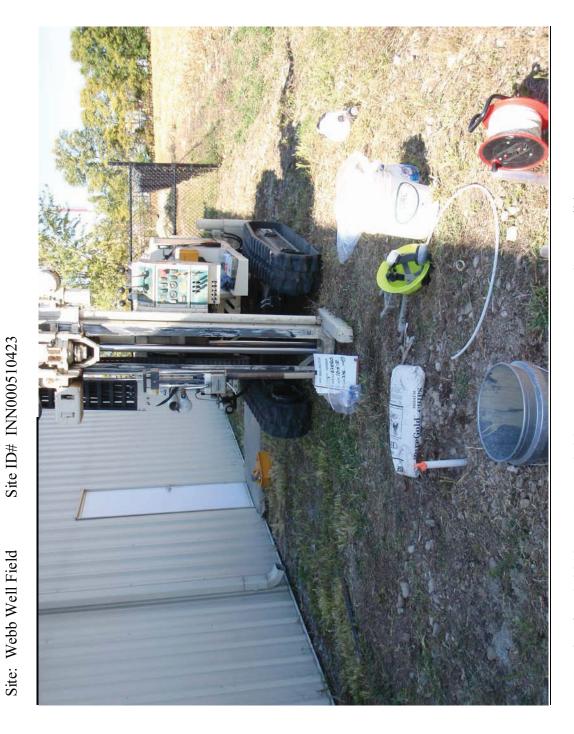
WEATHER: Sunny Mild Ground Water, Duplicate SAMPLE TYPE: **TIME**: 2:46 PM **DATE**: October 6, 2010 SAMPLE ID # E2RQ0 DESCRIPTION: Taken with background of sample E2RQ0 collected at Atlas Copco facility, Boring 3, 30' deep Duplicate of E2RP9.

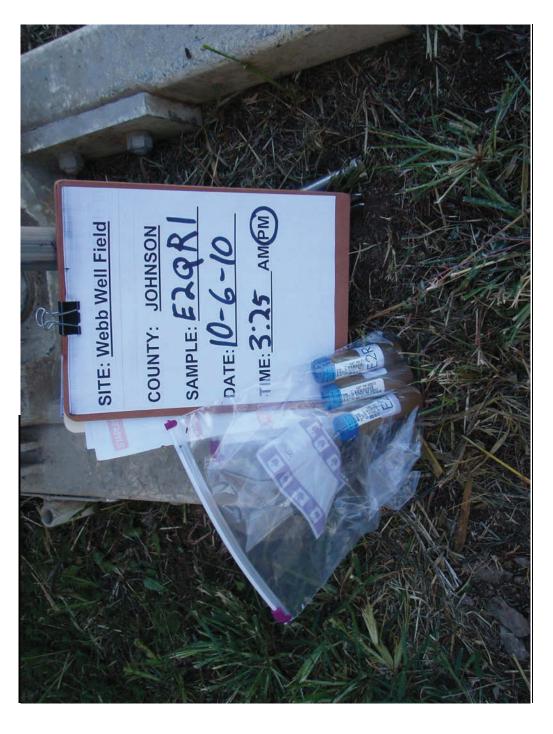
DATE: October 6, 2010TIME: 2:46 PMWEATHER: Sunny MildSAMPLE ID # E2RQ1SAMPLE TYPE: Ground Water

DESCRIPTION: Close up of sample E2RQ1 collected at Atlas Copco facility, Boring 3, 15' deep.

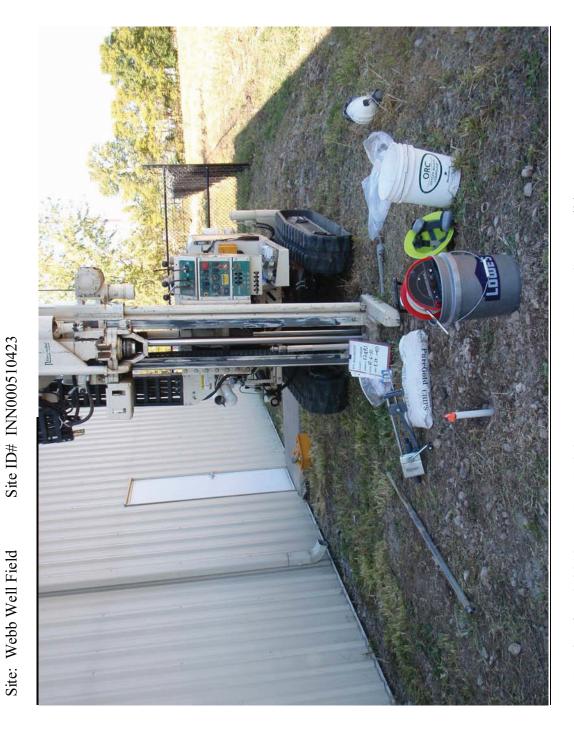
WEATHER: Sunny Mild Ground Water SAMPLE TYPE: **TIME**: 3:25 PM DATE: October 6, 2010 SAMPLE ID # E2RQ1 **DESCRIPTION:** Taken with background of sample E2RQ1 collected at Atlas Copco facility, Boring 3, 15' deep.

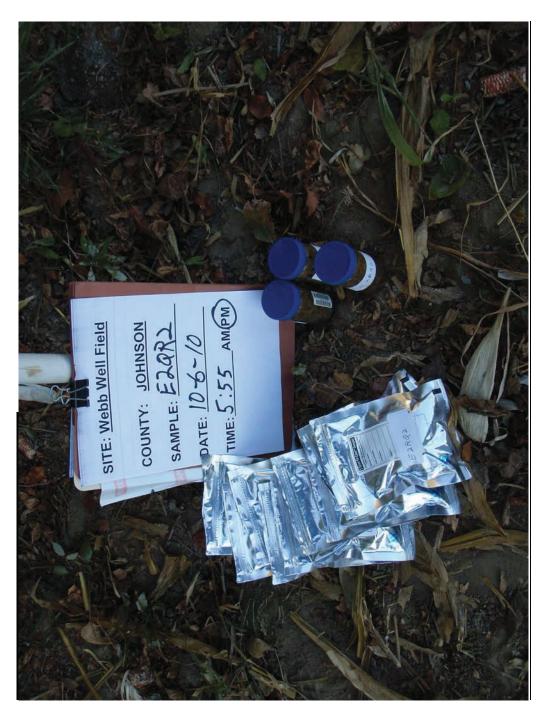
DATE: October 6, 2010TIME: 5:55 PMWEATHER: Sunny MildSAMPLE ID # E2RQ2SAMPLE TYPE: Subsurface Soil, MS/MSD

DESCRIPTION: Close up of sample E2RQ2 collected at corner of tree line and creek, Boring 4, 7-9' deep.

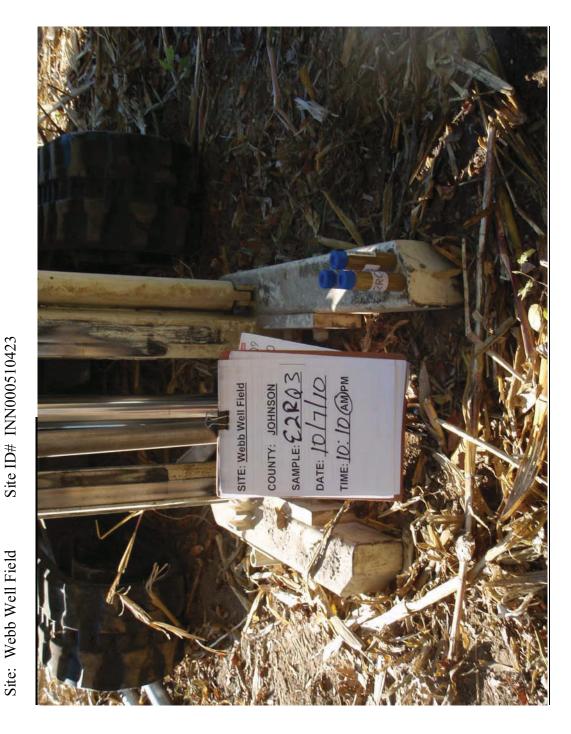
WEATHER: Sunny Mild **SAMPLE TYPE:** Ground Water **TIME**: 10:10 AM DATE: October 7, 2010 SAMPLE ID # E2RQ3 **DESCRIPTION:** Close up of sample E2RQ3 collected at corner of tree line and creek, Boring 4, 38' deep.

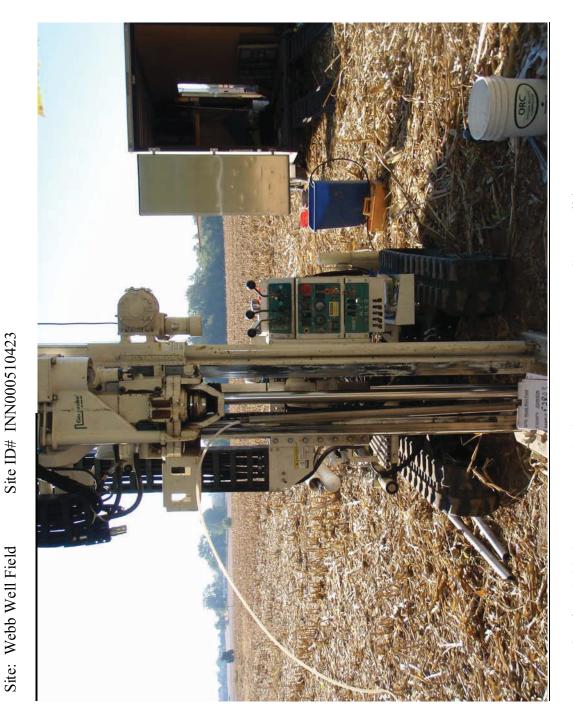
WEATHER: Sunny Mild **SAMPLE TYPE:** Ground Water **TIME**: 10:10 AM DATE: October 6, 2010 SAMPLE ID # E2RQ3 **DESCRIPTION:** Taken with background of sample E2RQ3 collected at corner of tree line and creek,

Boring 4, 38' deep.

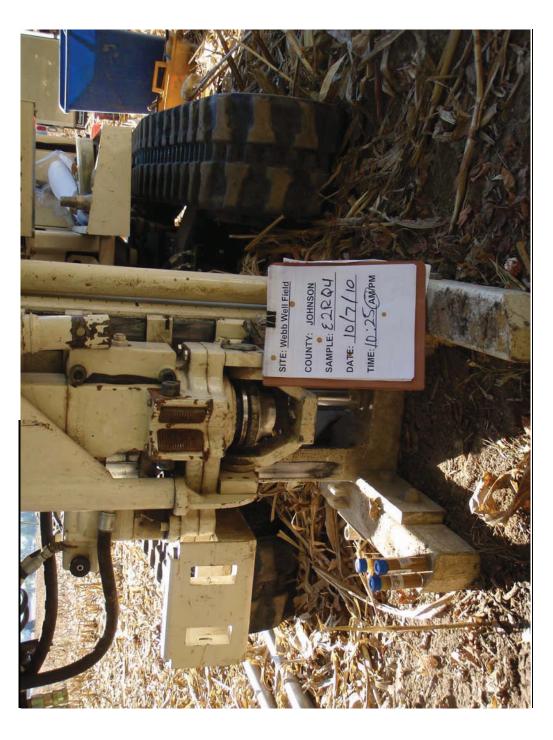
DATE: October 7, 2010TIME: 10:25 AMWEATHER: Sunny MildSAMPLE ID # E2RQ4SAMPLE TYPE: Ground Water

DESCRIPTION: Close up of sample E2RQ4 collected at corner of tree line and creek, Boring 4, 28' deep.

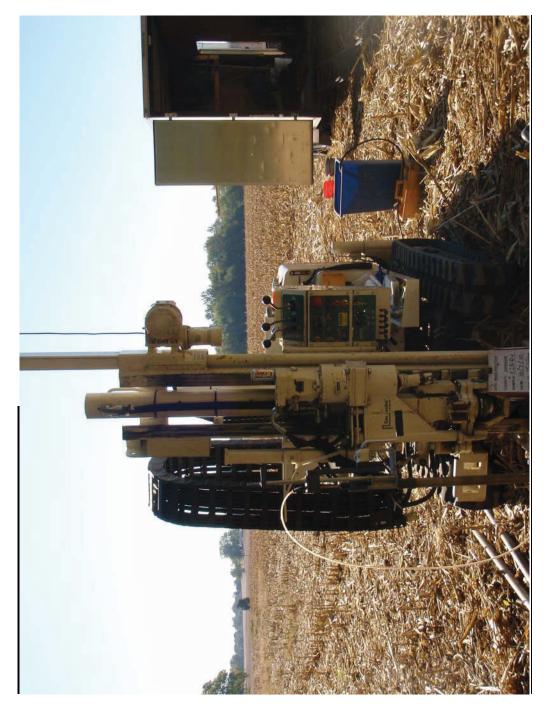
DATE: October 7, 2010TIME: 10:10 AMWEATHER: Sunny MildSAMPLE ID # E2RQ4SAMPLE TYPE: Ground Water

DESCRIPTION: Taken with background of sample E2RQ4 collected at corner of tree line and creek, Boring 4, 28' deep.

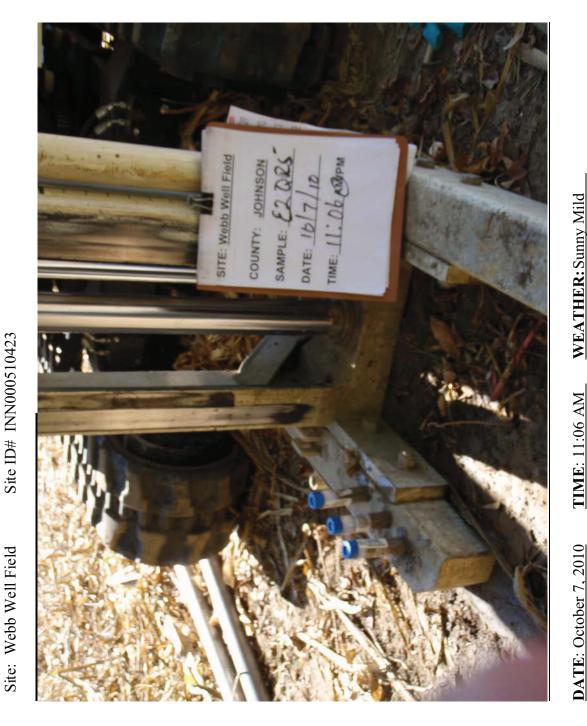
SAMPLE TYPE: Ground Water **TIME**: 11:06 AM DATE: October 7, 2010 SAMPLE ID # E2RQ5

DESCRIPTION: Close up of sample E2RQ5 collected at corner of tree line and creek, Boring 4, 14' deep.

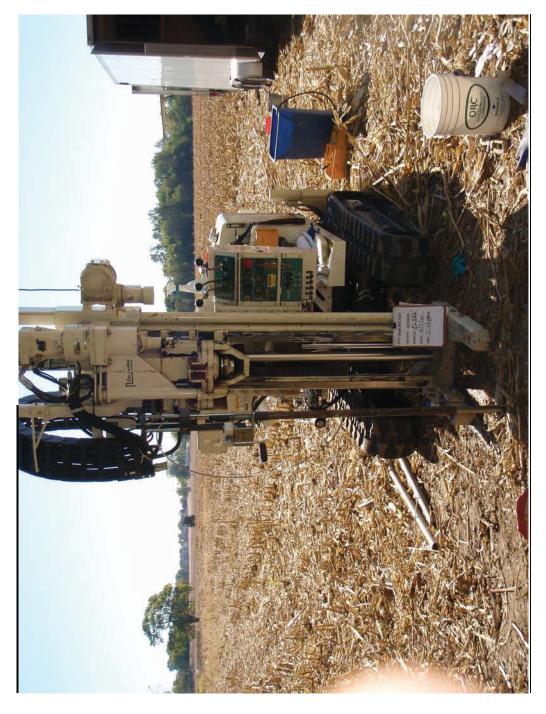
WEATHER: Sunny Mild **SAMPLE TYPE:** Ground Water **TIME**: 11:05 AM DATE: October 7, 2010 SAMPLE ID # E2RQ5 **DESCRIPTION:** Taken with background of sample E2RQ5 collected at corner of tree line and creek, Boring 4, 14' deep.

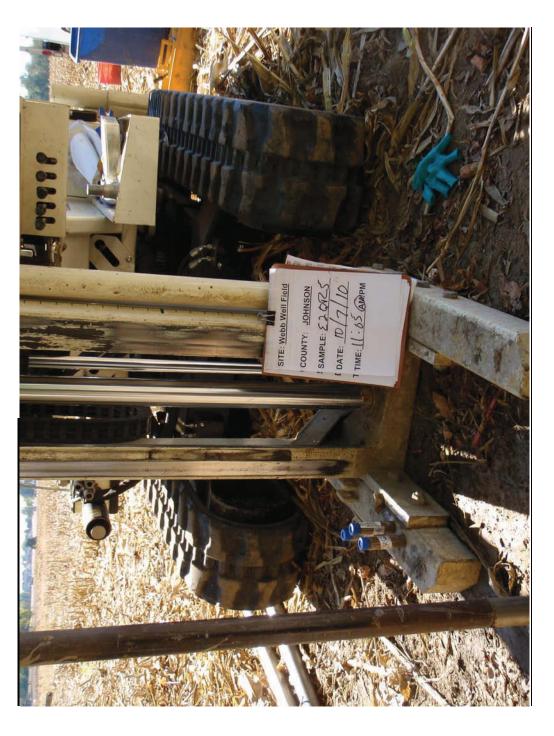
DATE: October 7, 2010TIME: 11:05 AMWEATHER: Sunny MildSAMPLE ID # E2RQ5SAMPLE TYPE: Ground Water

DESCRIPTION: Close up of sample E2RQ5 collected at corner of tree line and creek, Boring 4, 14' deep.

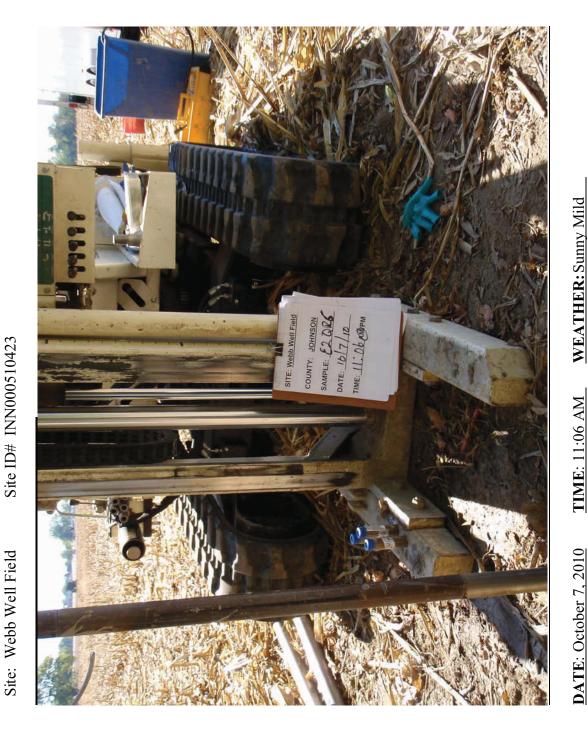
SAMPLE TYPE: Ground Water Duplicate **TIME**: 11:06 AM DATE: October 7, 2010 SAMPLE ID # E2RQ6 **DESCRIPTION:** Close up of sample E2RQ6 collected at corner of tree line and creek, Boring 4, 14' deep. Duplicate of E2RQ5.

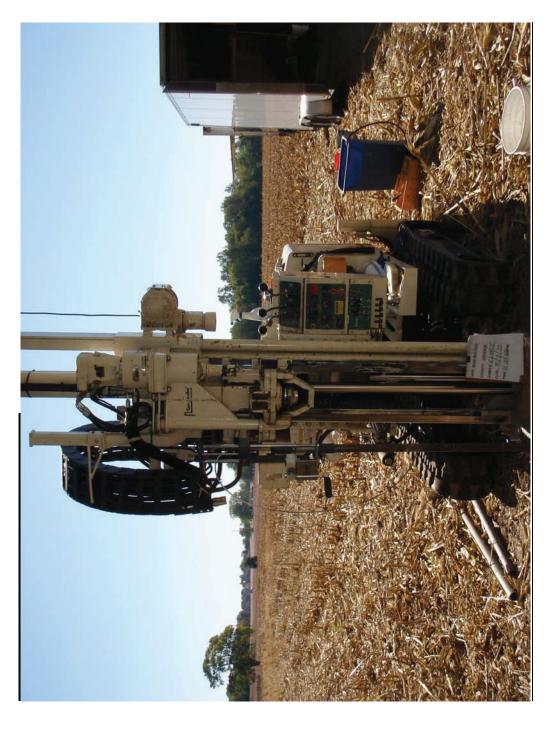
DATE: October 7, 2010TIME: 11:06 AMWEATHER: Sunny MildSAMPLE ID # E2RQ6SAMPLE TYPE: Ground Water, Duplicate

DESCRIPTION: Taken with background of sample E2RQ6 collected at corner of tree line and creek, Boring 4, 14' deep. Duplicate of E2RQ5.
